# Career Probationary Fire Fighter Dies While Participating in a Live-Fire Training Evolution at an Acquired Structure - Maryland

## Death in the Line of Duty...A summary of a NIOSH fire fighter fatality investigation

F2007-09 Date Released: December 8, 2008

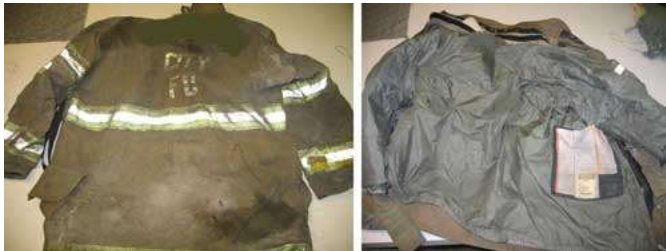
The turnout gear that was worn by the victim was sent by the department to the manufacturer for inspection. The NIOSH investigative team noted that there were little to no signs of heat exposure on either the coat or the pants ([Photos 1 and 2](#)).

**Photo 1. Turnout jacket shell and liner worn by victim.**

**Recommendation #7: Fire departments should develop an inspection criteria to ensure that all protective ensembles meet the requirements of NFPA 1851, Standard on Selection, Care, and Maintenance of Structural Fire Fighting Protective Ensembles.**

The latest edition of NFPA 1851, August 2007, recommends mandatory retirement for all structural fire fighting protective gear at 10 years from the date of manufacture regardless of the level of use. The fire department sent their old turnout gear that was removed from service to the training academy for use by recruits.

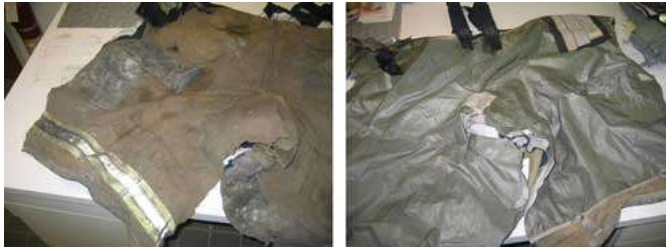
**Photo 2. Turnout pant shell and liner worn by victim.**

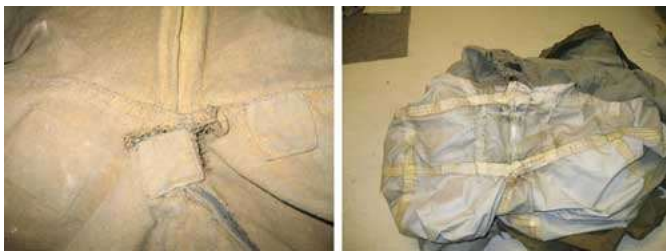
The coat was manufactured in 2002 and was reported by the manufacturer to still be in serviceable condition, but requiring extensive cleaning. The pants were manufactured in 1997. The manufacturer reported that the pants shell and liner were beyond their useful life and that they should have been retired. The manufacturer reported that thermal protection and moisture integrity was diminished due to abrasion and wear, especially in the crotch area of the pants ([Photo 3](#)).

**Photo 3. The repaired crotch area of the turnout pants shell, and inverted liner with diminished thermal integrity due to age and use.**

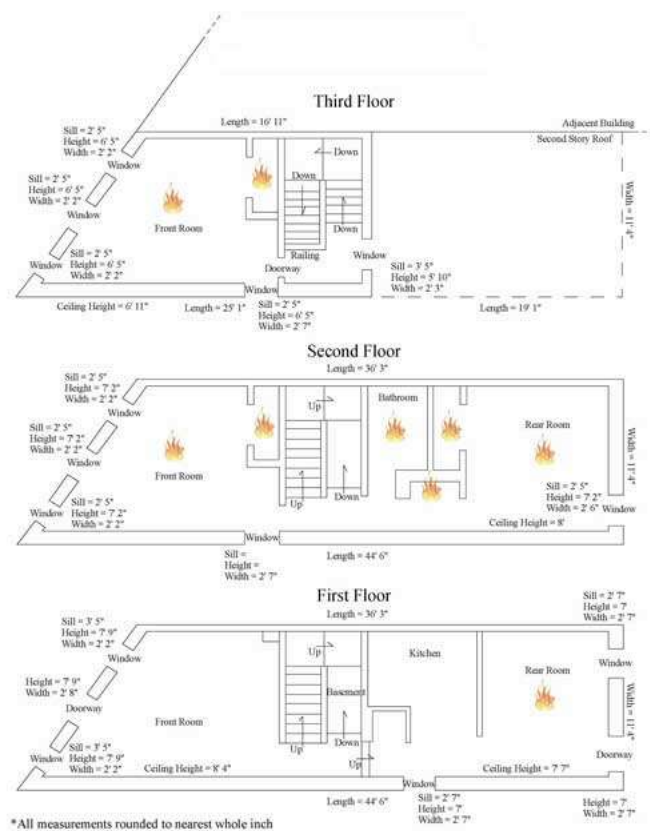
Figure 1. Layout of the fire structure. Fire symbols designate the location of the individual training fires set for the training evolution  
 (Courtesy of USFA Media Production Center).

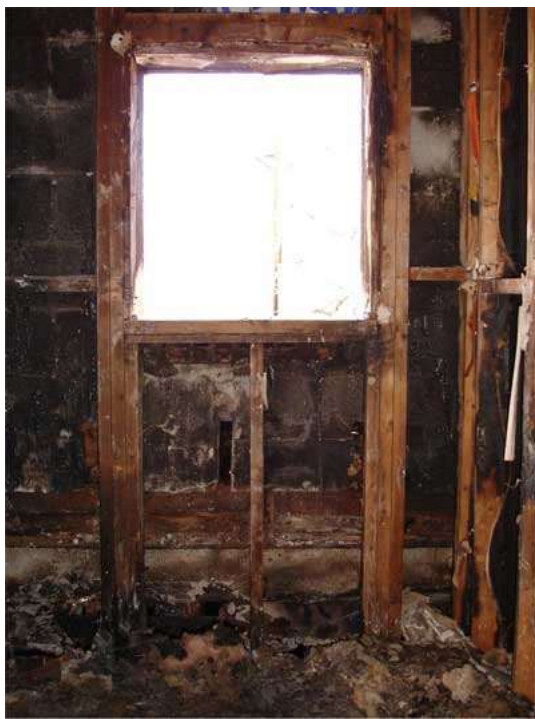
The first and second floors were approximately 44 feet long by 11 feet wide. The first floor consisted of a kitchen and a central stair case separating a front and a rear room. On the second floor, a bathroom and the staircase separated a rear and front bedroom. The third floor was above only the front portion of the townhouse. It had a front bedroom and a hallway that led to the stairway. The landing at the top of the stairs to the third floor contained a window on the C-side wall ([Figure 1](#)). The window sill was approximately 3-foot 5-inches above the floor and approximately 2-foot 3-inches wide ([Photo 4](#)).

Photo 4. Window sill on third floor landing looking towards the rear or C-side of the structure. Sill is 41-inches above floor level.

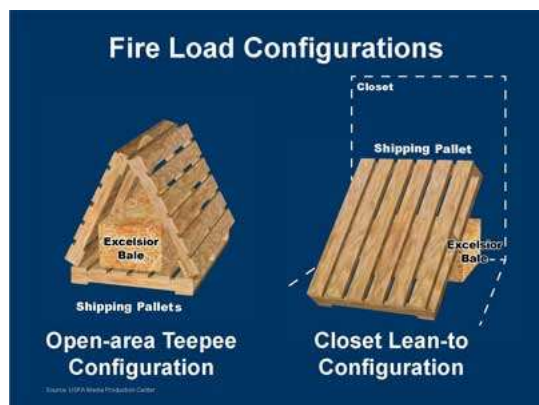
Through interviews it was determined that at least 12 wooden pallets, 11 bales of excelsior, and miscellaneous trash from the structure were used to light the fires in either a teepee or a lean-to configuration. The teepee arrangement consisted of a pallet flat on the floor with two others on top leaning into the center supporting one another. A bale of excelsior was placed in the void area. The lean-to consisted of a pallet leaning against a wall with a bale of excelsior underneath (Figure 2).

Figure 2. Example of fire load configurations  
(Courtesy of USFA Media Production Center).

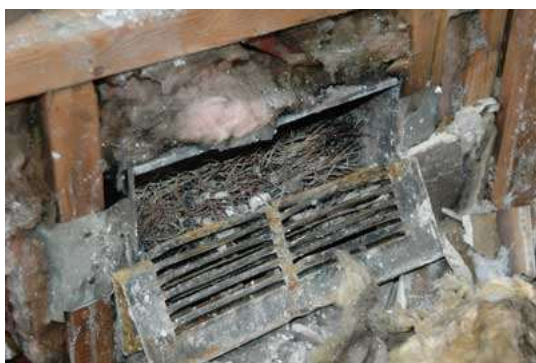
Through the interviews and during the walkthrough it was noted that excelsior was also stuffed into wall and ceiling openings, duct work vents, and behind drywall where it existed and/or was accessible (Photo 5).

Photo 5. Excelsior that was stuffed into duct work vents.

Discussion: Fire department policy and Maryland State law require compliance with NFPA 1403, Standard for Live Fire Training Evolutions. It is imperative that fire departments develop or follow the programs they have in place to ensure compliance with NFPA 1403.<sup>1</sup> In this incident, specific examples of non-compliance with NFPA 1403 include, but are not limited to: lack of an incident command system; lack of a personnel accountability system; lack of an incident safety officer; inadequate preparation of the structure for live-fire training; insufficient water supply; the absence of a method of fire ground communication among the officer-in-charge and fire fighters; holes in walls, ceilings, and floors that were not patched; the number of training fires set; the locations of the training fires; instructors that did not have the recommended qualifications; an absence of pre-burn briefings and a walk-through, and extensive fuel loads.

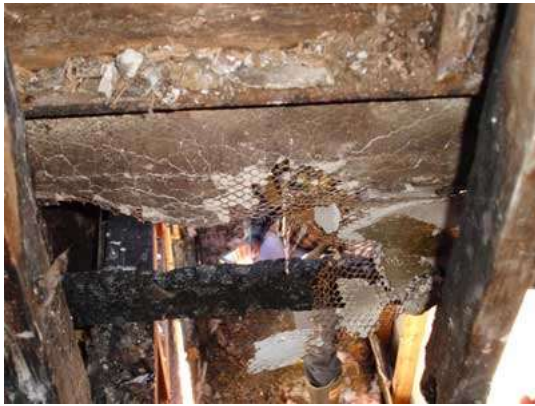
Conditions on the stairwells between the second and third floors deteriorated due to the fire drawing air and venting up the stairwell which was acting like a chimney for the heat and flames from the fires on the first and second floors. Heat and flames from the rear area of the second floor were also extending directly into the stairwell area. This was likely due to the ceiling having been pulled down in the bedroom during previous training exercises, and the fire entering the attic area under the second floor roof (Figure 3). The heat and flames exited this area through the voids in the wall on the stairwell and just below the window on the third floor landing (Photo 6).

**Photo 6. Void in wall just below window on third floor landing.**

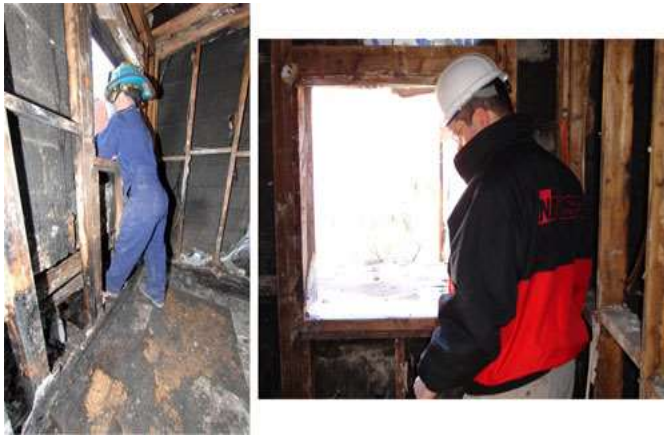
The victim also attempted to exit through the window, but was severely impeded due to the height of the window sill and possible obstructions (Photo 7).

Photo 7. ATF investigator on the left is approximately the same height as the victim. NIOSH investigator on the right is approximately the same height as the Engine 1 adjunct instructor.

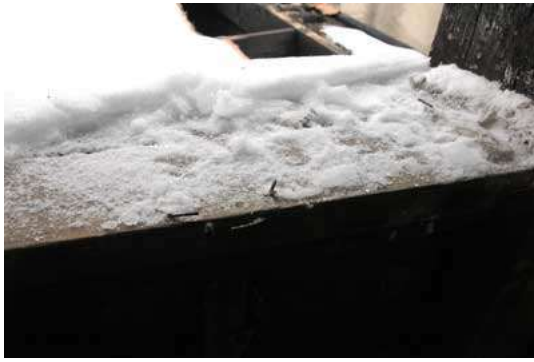
The adjunct instructor from Engine 1 had immediately returned to the window after helping the second fire fighter on the line exit. The victim was at the window screaming for him to get her out of there. He reached in and grabbed her by her SCBA harness. He got her upper body out of the window, but could not pull her lower body through. He was pleading with her to help, but she said she couldn't. He began yelling for help to anyone who could hear. He lost his grip and she slipped back inside the window. He reached back in to get her and her mask and helmet were off to one side exposing her face. Note: It is uncertain why the victim's mask became partially dislodged. It was reported that the victim had several incidents during her training at the academy where she had experienced mask claustrophobia and would panic and remove her mask prematurely. However, she could have removed it in an attempt to articulate to the other recruits to retreat. Or, it could have also become dislodged from being caught on the window sill or a nail protruding from the window sill (Photo 8).

Photo 8. Nails that were exposed at the window sill on the third floor landing.

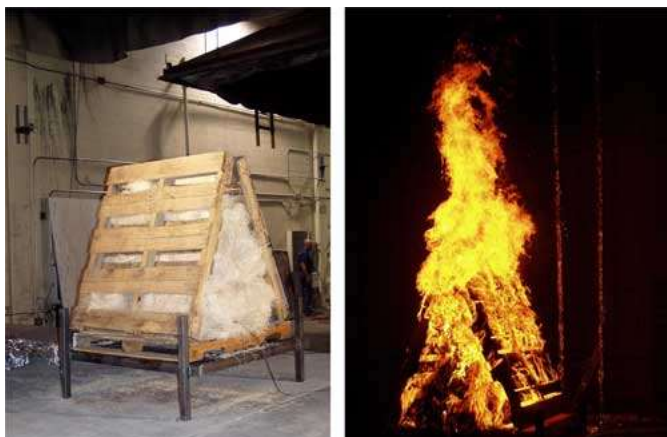
A variety of pallets were used since there is no “standard” pallet that is identified or used in fire fighter training. The total weights for three pallets ranged from 90 to 150 lbs in the NIST experiments. The resulting peak heat release rates ranged from 1,500 kW to 3,000 kW ([Photo 9](#)).

Photo 9. NIST heat release experiment.

In this incident, the three lean-to fires could be considered as equaling one “A-frame” fire in the NIST experiment. Taking into account all of the staged training fires in this incident, the training fires equaled approximately four “A-frame” fires, suggesting a heat release rate of approximately 8,000kW. With the addition of the fire load in the rear room on the first floor, the exposed wood framing members, the insulation, and added bales of excelsior, it can be estimated that the total heat release rate for the structure was in excess of 10,000 kW. It is unknown whether a flashover occurred at this training exercise. Based on the ventilation limits of a residential room with a single open doorway, the minimum amount of energy needed to flashover a room is approximately 2,000 kW.<sup>c</sup>
