# Career Probationary Fire Fighter Dies While Participating in a Live-Fire Training Evolution at an Acquired Structure - Maryland

## Death in the Line of Duty...A summary of a NIOSH fire fighter fatality investigation

F2007-09 Date Released: December 8, 2008

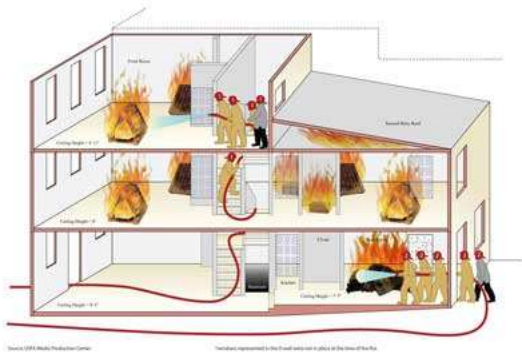
On the third floor the instructor and victim did not see any fire in the front room, just grayish smoke. The victim started to flow water as her instructor called for more hose. Another student, the back-up fire fighter, was positioned at the turn in the stairs between the second and third floor in order to flake the line around the corner. The third fire fighter on the line was on the stairs going down to the second floor, and the fourth fire fighter was flaking hose around the corner at the second floor landing (Figure 3).

**Figure 3. Engine 1 crew on third floor. Engine 2 suppressing fire in rear room on first floor**  
(Courtesy of USFA Media Production Center).

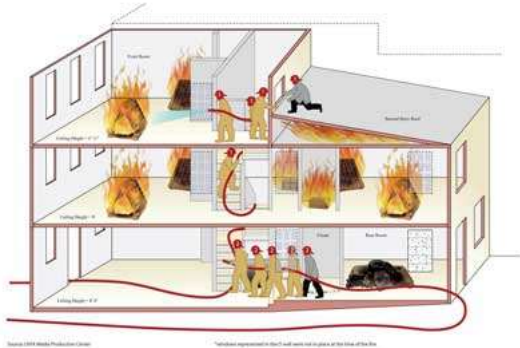
The Engine 1 adjunct instructor felt a rush of intense heat and knew something was wrong. He did not have a radio to make contact with the officer in charge, nor did he know of any alternative means of exit because they had not completed a walk-through or any pre-burn briefing prior to the training evolution. He leaned out of the window on the third floor landing to assess his situation and possibly make contact with someone. The back-up fire fighter came up the stairs and stated that she needed to exit because the conditions on the stairs were too intense. The adjunct instructor exited through the window onto the second floor roof and assisted the back-up fire fighter out of the window (Figure 4).

**Figure 4. Engine 1 personnel operating on third floor and stairwell. Engine 2 advancing to the second floor. Engine 1 Adjunct Instructor on roof, remainder of crew inside**  
(Courtesy of USFA Media Production Center).

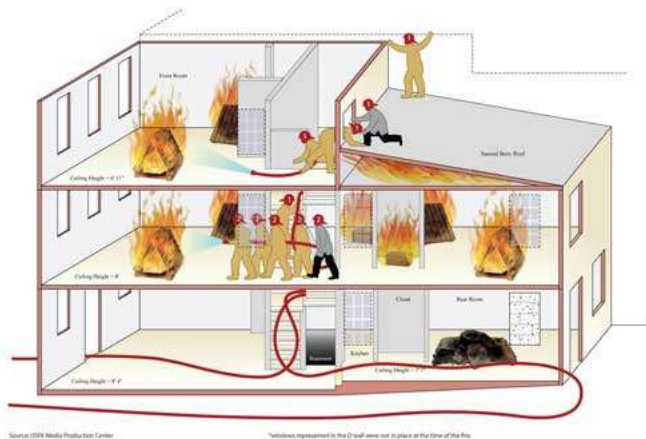
The two other recruits on Engine 1 were now on the landing between the second and third floors. The hose line was not advancing and they felt a rush of air go over them followed by heavy fire. They made their way to the bend of the stairs and saw the victim, who was alone, attempting to exit through the window. The victim was attempting to climb out of the window and screamed for them to retreat as the intense flames were venting out of the same window around her. The two recruits went back down the stairs and were faced with extensive fire. Note: The recruits stated that they didn't know what to think about the victim being stuck in the window. They didn't know if it was part of the training, and they didn't have anyway nor anyone to ask. They decided it would be best to fight fire instead of just leaving the building. They pulled the nozzle down from the third floor and started to fight the fire on the second floor where they met Engine 2 (Figure 5).

Figure 5. Engine 1 crew attempting to exit on to roof. Engine 2 crew suppressing fire in front room on second floor (Courtesy of USFA Media Production Center).

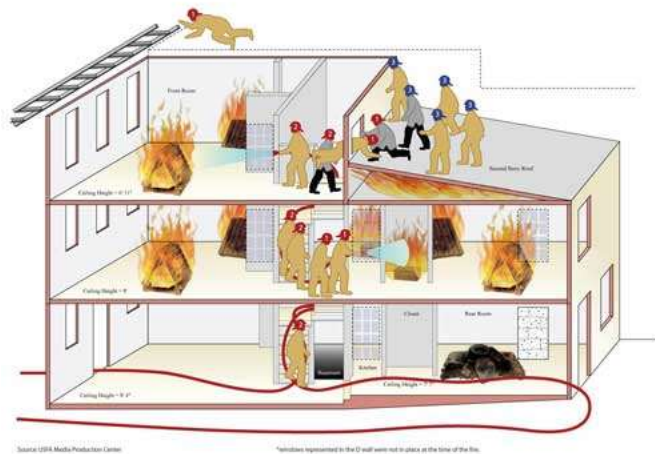
The adjunct instructor from Engine 2 had run up the stairs after hearing someone screaming. He could see the victim's body partially out of the window. As he got closer, he could see the adjunct instructor from Engine 1 attempting to pull the victim out of the window. The victim's head and shoulders were out of the window. The adjunct instructor from Engine 2 reached down and lifted her legs up to a horizontal position and she immediately was pulled out of the window. The adjunct instructor from Engine 2 went back down the stairs to get the crew from Engine 2 and knocked down the extensive fire on the third floor (Figure 6). Members from Truck 3 on the second floor roof initiated life saving support. She was quickly removed from the roof and transported to a shock trauma center where she was pronounced dead.

Figure 6. Engine 1 crew exiting to roof and down ladder. Engine 2 crew suppressing fire in front room of third floor. Truck 3 members assisting Engine 1 crew exiting window  
(Courtesy of USFA Media Production Center).
